# Results of airtightness test after flange tightening training

## 1. Introduction

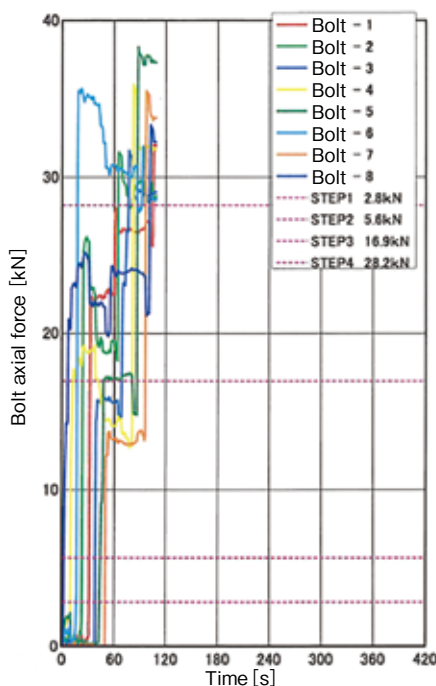
Figure4 Sheet gasket (No.GF300) tightening axial force over time

- “☆☆☆” .....Torque value of bolts ① to ⑧ is within  $90 \pm 5\text{N}\cdot\text{m}$ , and no tendency of uneven tightening according to the line graph.
- “☆☆” .....Torque value of bolts ① to ⑧ is between  $90 \pm 5\text{N}\cdot\text{m}$  and  $90 \pm 10\text{N}\cdot\text{m}$ , and no tendency of uneven tightening according to the line graph.
- “☆” .....Torque value of bolts ① to ⑧ is under  $80\text{N}\cdot\text{m}$  or over  $100\text{N}\cdot\text{m}$ .

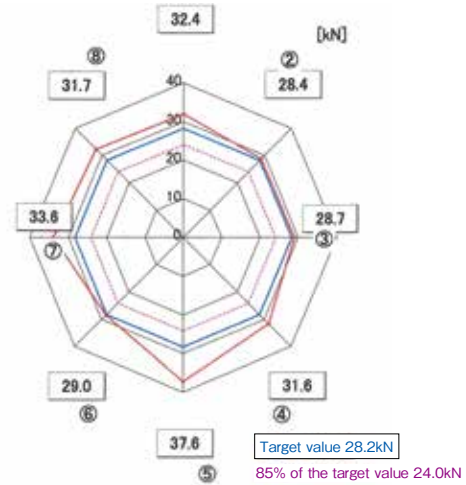
Figure5 Tightening axial force distribution of sheet gasket (No.GF300)

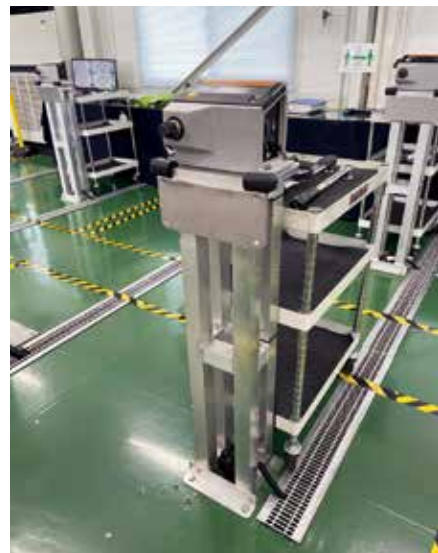
Figure6 Torque-sensor training device

- ① Explanation of tightening method  
Explain the method of tightening in a diagonal pattern and increasing the torque in 3 steps.
- ② Explanation of evaluation criteria  
Explain 2-1, and explain why under  $80\text{N}\cdot\text{m}$  is considered as a failure.
- ③ Training procedure  
After each trainee acquires the sense of torque values using the torque-sensor training device (See photograph), they are tested on the flange-tightening training device (Photograph attached) and when this is completed, the results are printed out on the spot for evaluation.

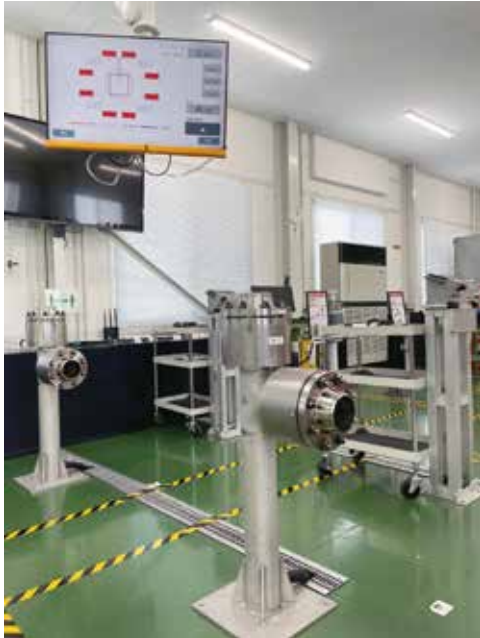
Figure7 Flange-tightening training device
