Precautions when considering usage and troubleshooting (Flector[™])

Takanori Sakamoto H&S Sales Div. Technical Solutions Group Technical Paper

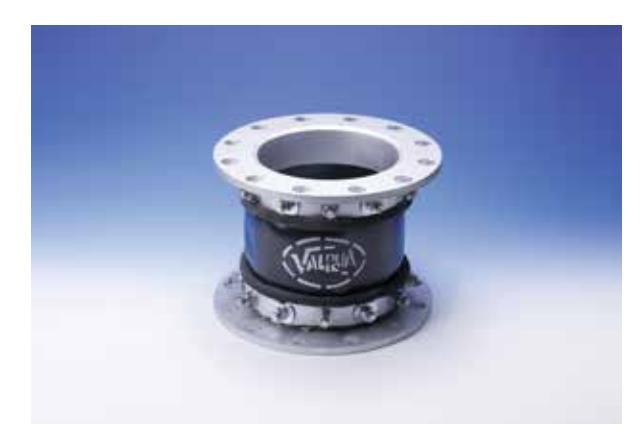
This product is a combination of metallic parts (flanges, etc.) and a non-metallic cover (Figure1).The cover part is made of integrally molded rubber and reinforcing fabric, therefore eliminating any joints and providing excellent airtightness, long-term flexibility, and radiation resistance.

Figure1 Photograph of external view of No.FLEX

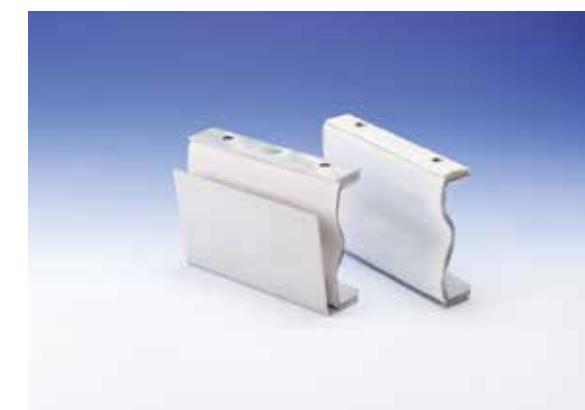
This product is a combination of a cover and metallic parts (flanges, etc.) formed by sewing and bonding organic and inorganic cloth, film, etc. (Figure2). It is used in a wide range of industries due to its high

Figure2 Photograph of section view of No.XP-221

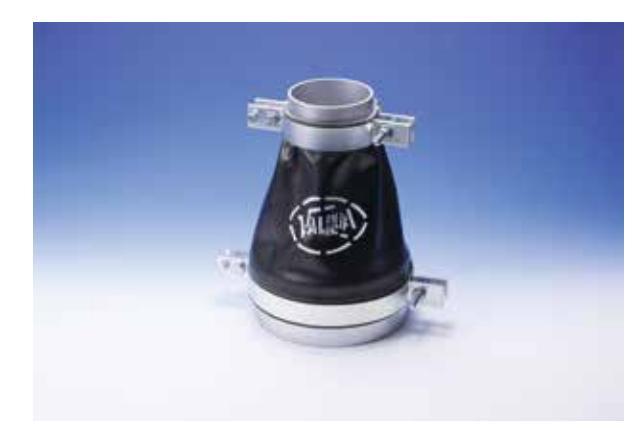
Figure3 Photograph of external view of No.PRBT

This product is made of the same cover material as No.FLEX, and is installed by wrapping a fan-shaped cover with fasteners sewn on both ends around the pipe penetration area, closing the fasteners, sealing the area with an amorphous sealing material, and then fixing both ends with metallic bands (Figure3). This product is specially designed to seal the gap between the pipe at the pipe penetration area and to absorb pipe displacement.

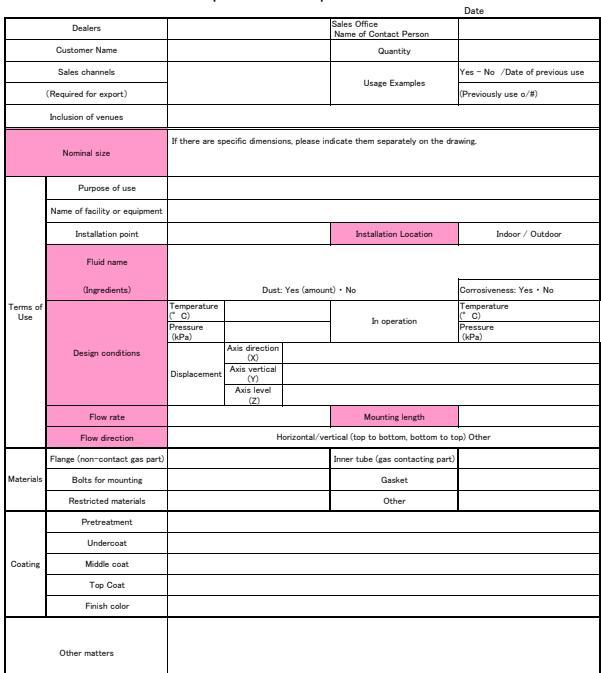
Figure4 shows a product specification sheet. The items colored in pink are the minimum necessary information. If there is insufficient or incorrect information, it will

Figure4 Product specification sheet

As mentioned above, it is possible to design the product if the pink sections in Figure4 are provided. However, since troubles such as those mentioned above may occur due to insufficient information, it is important that we proactively confirm and obtain detailed information from our customers. Even so, installation problems are more common than other products, and since the installation is done by the customer, particular attention should be paid to the following:

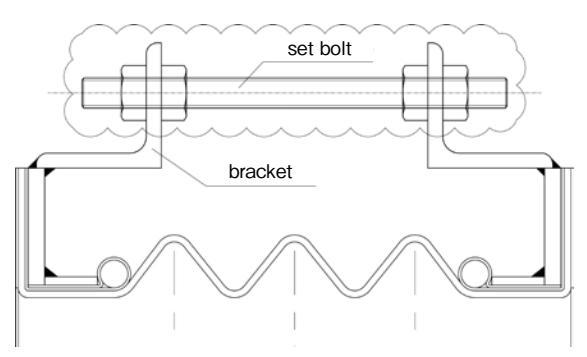
Figure5 Half-sectional view of XP-221 equipped with a set bolt

A half-sectional view of the XP-221 equipped with a set bolt is shown in Figure5. Set bolts are installed to maintain the structure of the product during transportation and storage. Although instructions are given to remove the set bolts when the product is installed, it may happen that the product is operated without removing them. Since the primary role of expansion joints is to absorb displacement through expansion and contraction, it is pointless to leave the rigid set bolts in place.

Occasionally, mounting is done with the bolts slightly loosened, but the maximum displacement cannot be absorbed with the set bolts in place, so they must be removed after the product is installed.

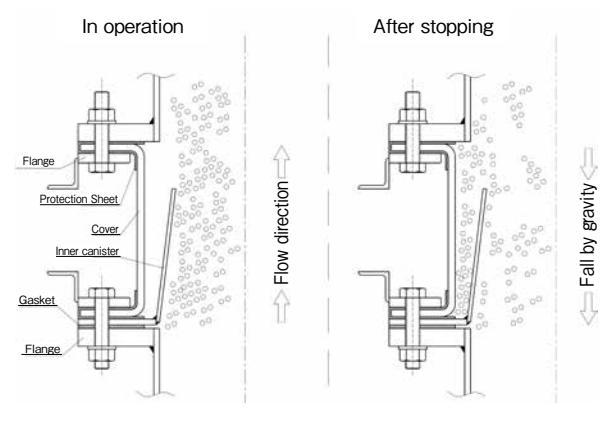
Normally, if there is no specific instruction, the product is designed to be installed parallel to the ground. In this example, the design included an inner cylinder because the fluid was powder. Figure6 shows an image of the XP-221 with the inner cylinder during shutdown. Since it was installed perpendicular to the ground, powder accumulated between the cover and the inner cylinder during shutdown. This happened because there was no information about the mounting direction and negative pressure. If powder accumulates between the cover and inner cylinder, it will affect the absorption of displacement of the cover, and the powder will scrape against the cover during displacement, leading to damage to the cover.

Figure6 Image of the XP-221 with inner cylinder during shutdown

Countermeasures include filling the gap between the inner cylinder and the cover with heat insulating material or installing both inner cylinders in order to eliminate the gap where fluid can enter.

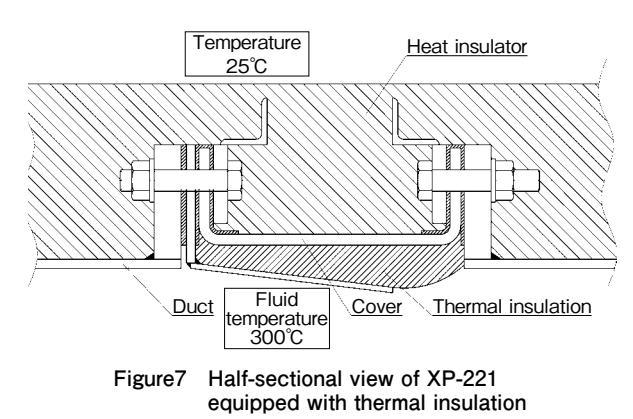
Although we do not recommend the application of thermal insulation to the product, there have been cases where it was wrapped around the expansion joint as well, in order to maintain thermal efficiency of the equipment. Figure7 shows a half-sectional view of the XP-221 equipped with thermal insulation. When insulation is applied, heat from the fluid is trapped without hardly being dissipated to the outside air. Wrapping insulation around can lead to a loss of elasticity and heat-induced deterioration of the cover, eventually damaging the product. If thermal efficiency is a priority, shortened product lifetime and damage must be considered in advance. As a countermeasure, considering outside installation, CR tarpaulin, which has good weather resistance, was selected as the most outmost layer, but since its heat resistance is low, in this case, we applied a cover made of heat-resistant inorganic cloth and PTFE film.
